Manhole Inspection Summary

Manhole # S43M__018MH

Insp Date: **6/5/08 10:12 AM**

Location Address: **814 s bond st**

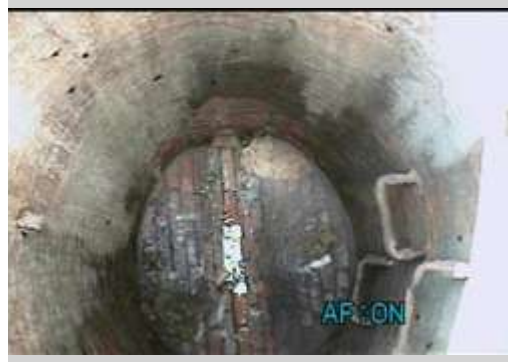
Top View

top view & steps

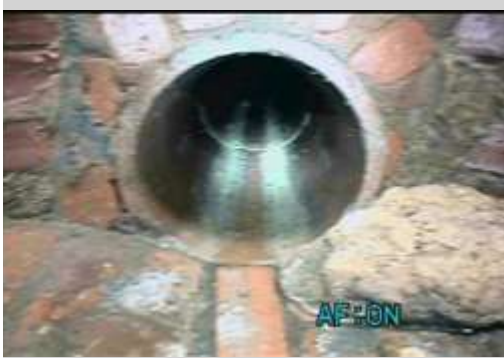
misc

channel debris

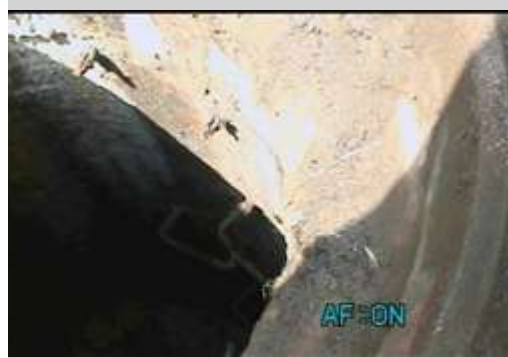
Defect 1

Frame Offset: **4** (in.) Condition: ☒ Sound ☐ Cracked ☐ Leaks

Steps Count: **4** Missing: **1** ☒ **Corroded**

offset , missing/corroded steps

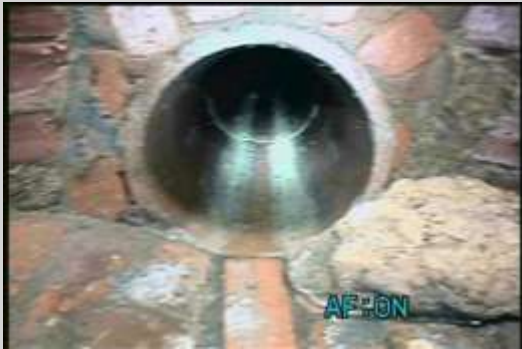
12 O'Clock Outflow

8 in. Circular Gravity Sewer
Pipe Out @ 12 O'Clock

Pipe Material: **Clay** ☐ Pipe Lined

Invert Depth: **9.13** (ft.) Flow Characteristics: **None**

Infiltration: **None** Pipe Seal Cond: **Unknown**

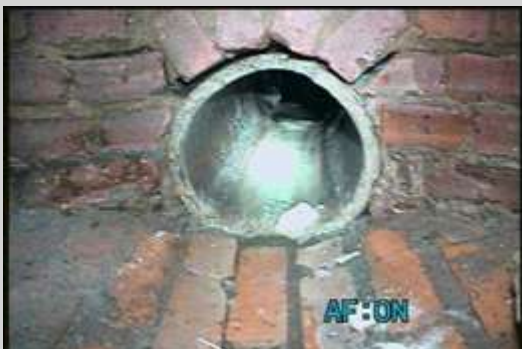
6 O'Clock Inflow

8 in. Circular Gravity Sewer
Pipe In @ 6 O'Clock

Pipe Material: **Clay** ☐ Pipe Lined

Invert Depth: **9.07** (ft.) Flow Characteristics: **None**

Infiltration: **None** Pipe Seal Cond: **Unknown**
